TEST REPORT

Report No.: G1418.01-301-44

SKYCO SKYLIGHTS Costa Mesa, California

PRODUCT TYPE: Fall Protection Security Bars **SERIES/MODEL**: FSB-1A/FSB-10A/FSB-1/FSB-10

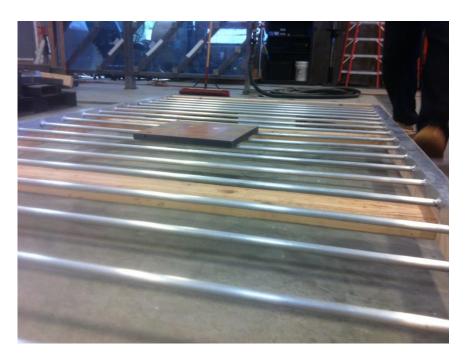
Photo No. 1 Specimen #1 after 200 lb. static load

Test	Load Location	Results
400 lbf	Center of bars	No visible damage

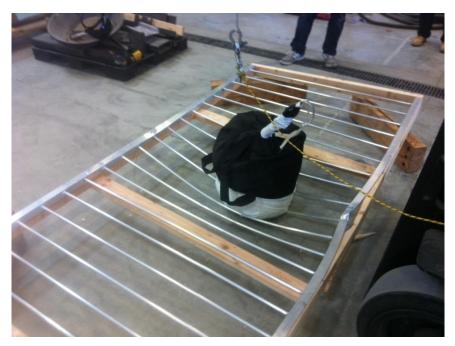
Photo No. 2 Specimen #1 after 200 lb. dynamic impact from 48"

Note #1: At the 48' drop height, bars bent toward the interior of the assembly but maintained their construction and supported the load.

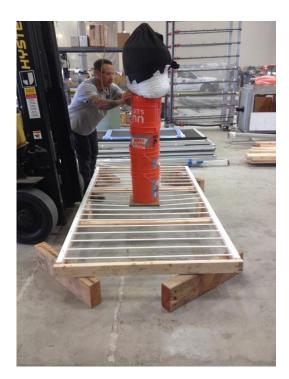
Photo No. 3 Test Specimen #2 during 200 lb. static load

Test	Results	Maximum Allowed
400 lbf	Center of bars	No visible damage

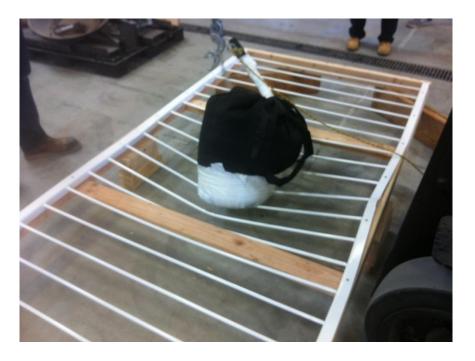
Photo No. 4 Test Specimen #2 after 200 lb. dynamic impact from 48"

Note #2: At the 48' drop height, bars bent toward the interior of the assembly but maintained their construction and supported the load.

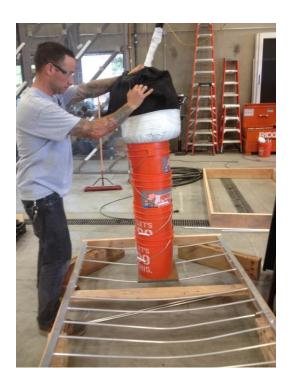
Photo No. 5 Test Specimen #3 during 200 lb. static test

Test	Results	Maximum Allowed
400 lbf	Center of bars	No visible damage

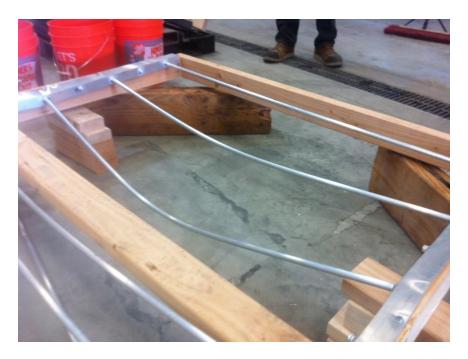
Photo No. 6 Test Specimen #3 after 200 lb. dynamic impact from 48"

Note #3: At the 48' drop height, bars bent toward the interior of the assembly but maintained their construction and supported the load.

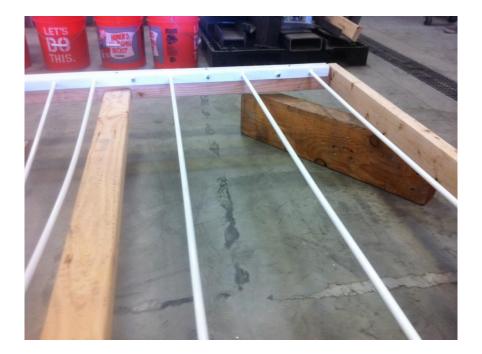
Photo No. 7 Test Specimen #4 after 200 lb. static test

Test	Results	Maximum Allowed
400 lbf	Center of bars	No visible damage

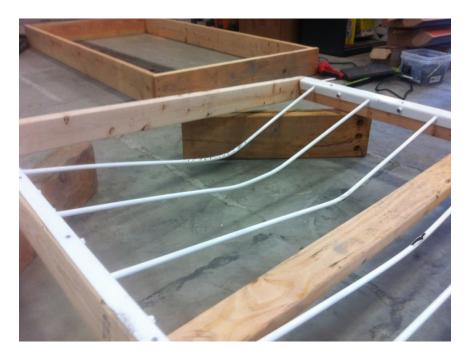
Photo No. 8 Test Specimen #4 after 200 lb. dynamic impact from 48"

Note #4: At the 48' drop height, bars bent toward the interior of the assembly but maintained their construction and supported the load.
