TEST REPORT

Report No.: E3508.02-301-44

SKYCO SKYLIGHTS Costa Mesa, California

SERIES/MODEL: 4896-A-S-CM-SPW-MF **PRODUCT TYPE**: Unit Skylight – Plastic Glazed

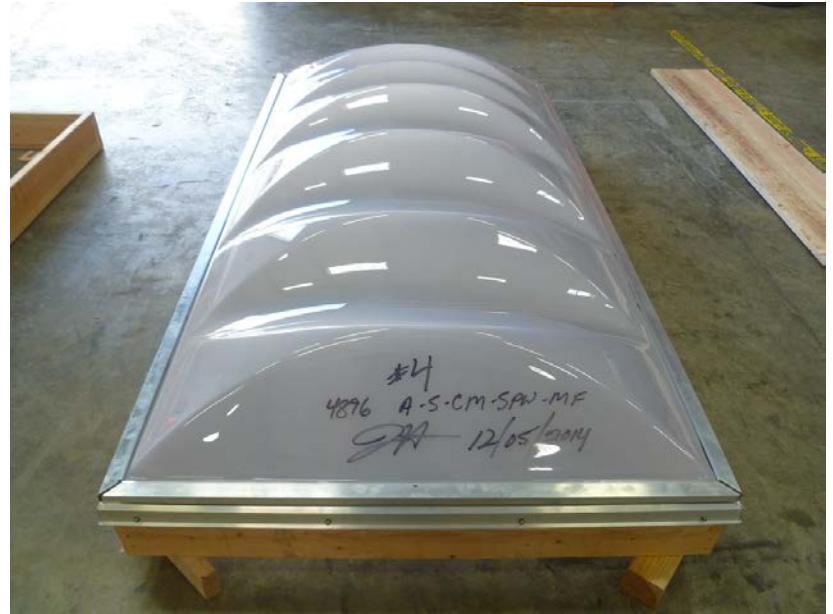
Test	Load Location	Results
400 lbf	Center of dome	No visible damage to dome or
400 IDI.		inversion of dome occurred.

Note: The 400 lbf. weight was gently applied perpendicular to the center of dome. After 60 seconds of rest time, there was no visible damage to skylight.

Photo No. 1 OSHA Safety Test After Load Applied

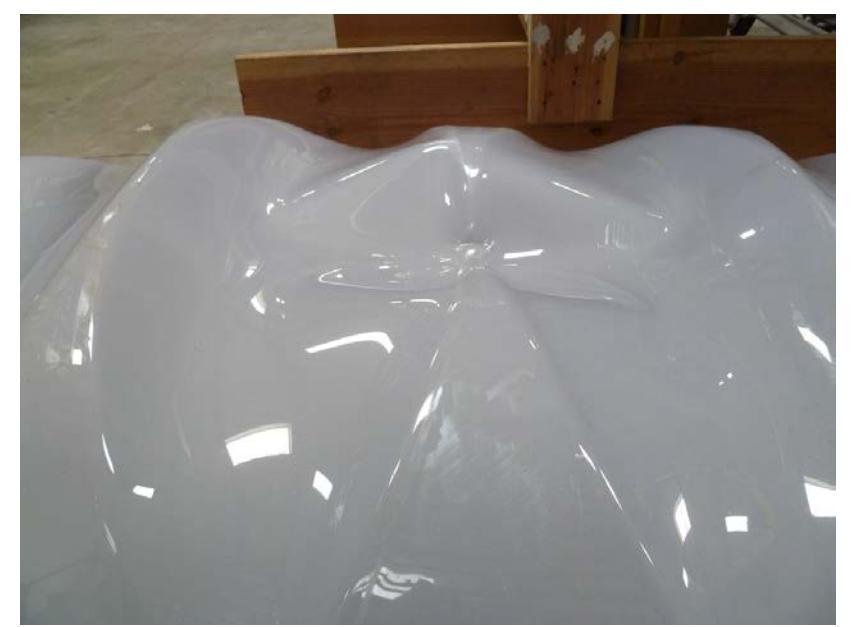
Test Method	Load Location	Results	
800 lbf-ft (4' drop height)	Center of dome	Dome ridge indented at point of impact, no visible damage or cracking of dome and no compromising of dome	
		perimeter retention.

Photo No. 2 OSHA Safety Drop Test After Load Applied – Inversion of Dome Ridge

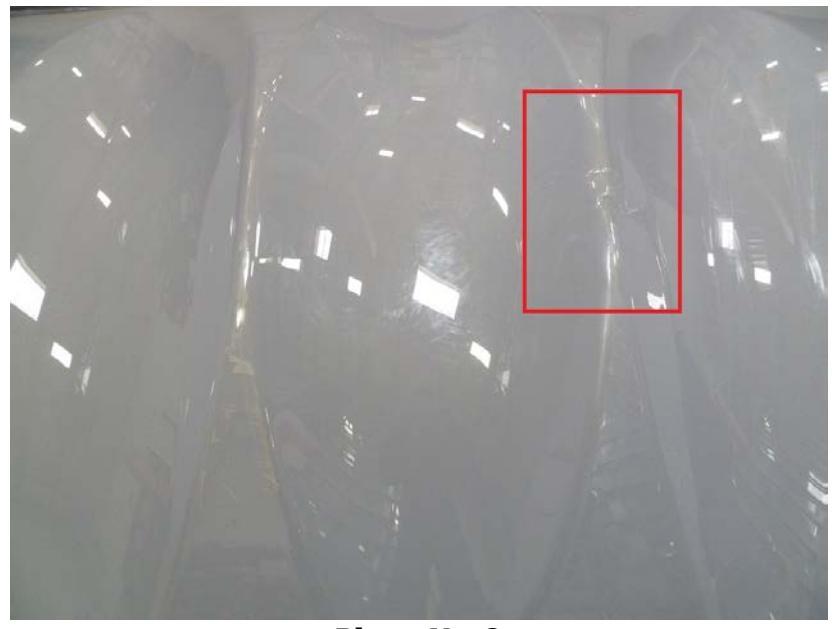
Note: The dome ridge returned to its original shape approximately 30 minutes after impact test occurred, a small crease in the dome remained at the point of impact inversion.

Photo No. 3 OSHA Safety Drop Test After Load Applied – Crease in Dome after Return of Dome Ridge
